Tide Mill Farm New Jersey Coastal Heritage Trail 100 Tide Mill Lane Salem Vicinity Salem County New Jersey

HABS No. NJ-994

HISTORIC AMERICAN BUILDINGS SURVEY

TIDE MILL FARM

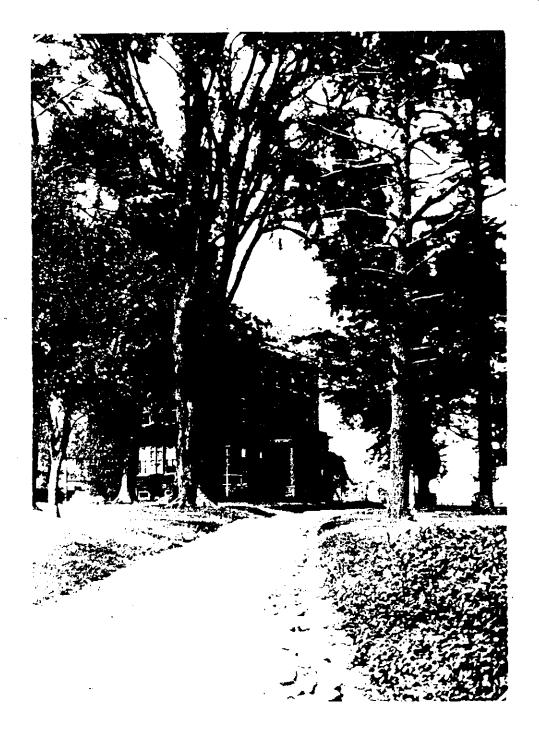
historic photograph, n.d. view looking north at east front and south side of house

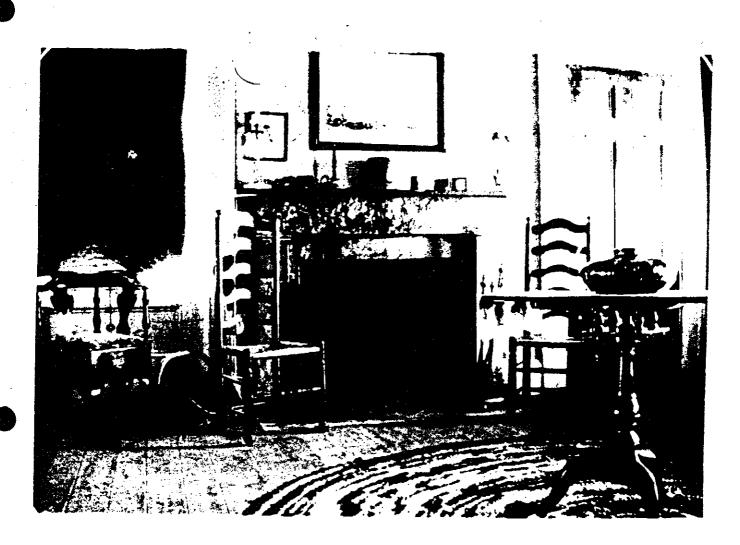
historic photograph, ca. 1900 southwest corner of the living room courtesy Abbott Family Papers

The living room's south wall, flanking the French doors, are identical dark-gray marhle mantles. The firehox openings are framed by fluted pilasters, plain frieze, and simple mantle shelf.

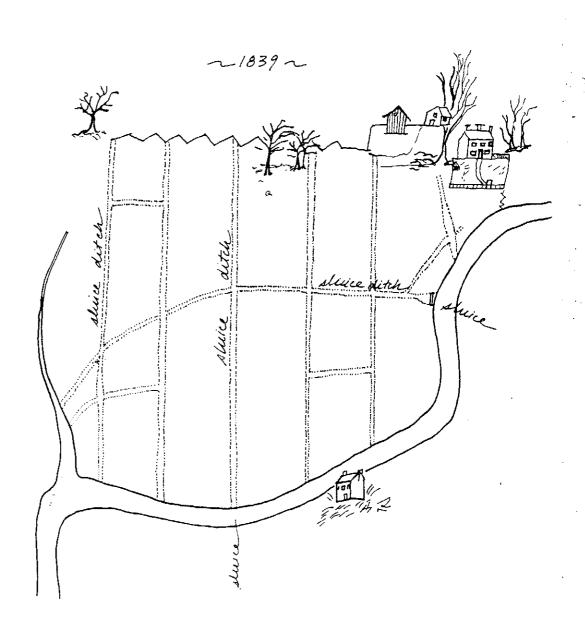
Sketch map showing Tide-Mill Farm area, 1839. Abbott Family Papers.

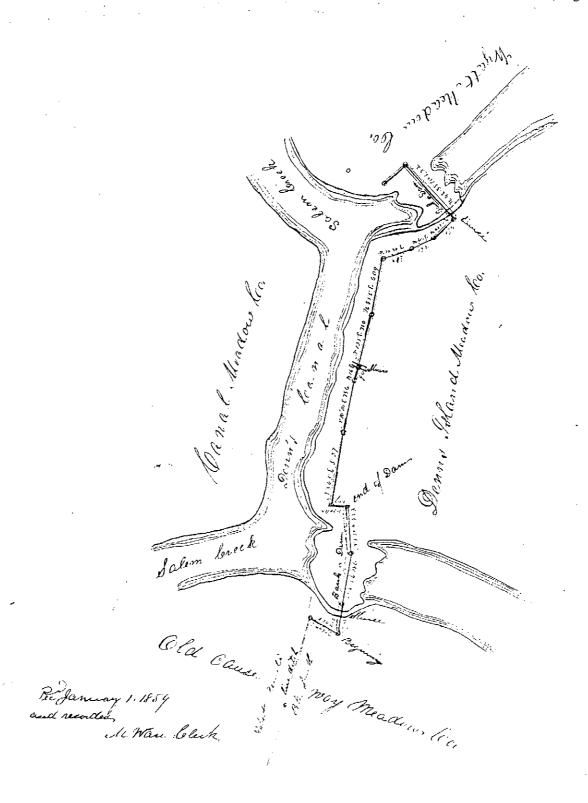
Survey map, recorded January 1, 1859. Salem County Historical Society.

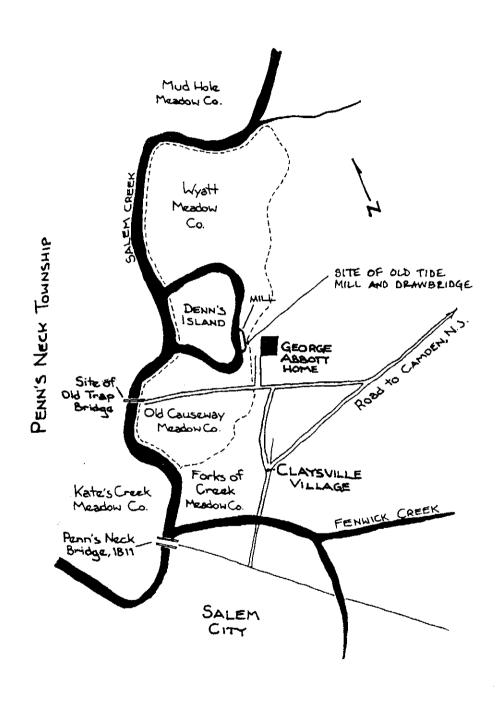
Illustration based on a 1920 sketch map by Henry Abbott, which accompanied a letter he sent to the U.S. Census. Abbott Family Papers.

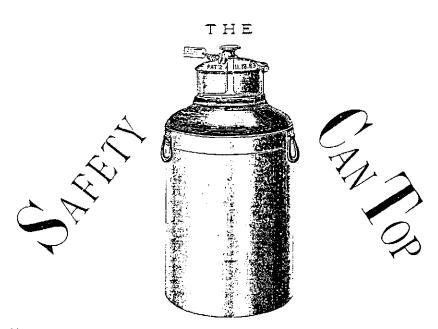
"The Safety Can Top," George Abbott, Jr., Inventor and Owner. Abbott Family Papers.

THE SAFETY CAN TOP, supplies a long felt need by remedying the defects of the Milk Can Tops now in general use. Its points of advantage are:—

1st.—Greater strength and durability. The Safety Can Top being constructed of the best refined maleable from is more durable than other parts of the can; while the lid now in use requires one or two renewals before the can is worn out.

Abbott's principle, that "where the health of babies and little children is at stake, no effort and no expense are to great to assure pure, safe milk for them," led the company to become one of the largest dairy companies on the East Coast, employing thousands of employees. The plant on Cohansey Street Bridgeton was a "model of efficiency and sanitation." Initially, milk was delivered to local customers via pushcart, and Abbott filled pails or cans suspended from a window or shutter. This was replaced with a horse-drawn wagon until 1884 when glass milk bottles were invented, after which standardized size and sterilization led to easy and sanitary home delivery. He then shipped larger quantities from Salem to Philadelphia by rail. He also patented a "Safety Can Top" (see page 23) for his milk cans in 1883, which prevented losing the contents or lid itself, as well as pilfering of cream off the top.

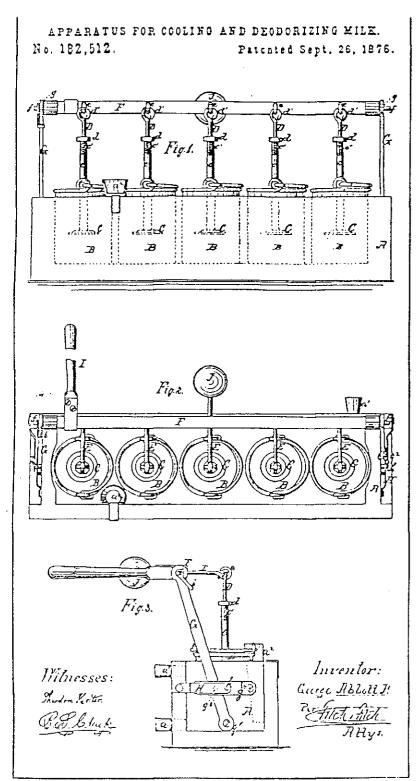
"Apparatus for Cooling and Deodorizing Milk. No. 182,512. Patented Sept. 26, 1876." George Abbott, Jr., Inventor. Abbott Family Papers.
